## Delaware WRAPS BMP Success Story

### Project: Cedar Tree Revetment & Forest Buffer, Atchison County

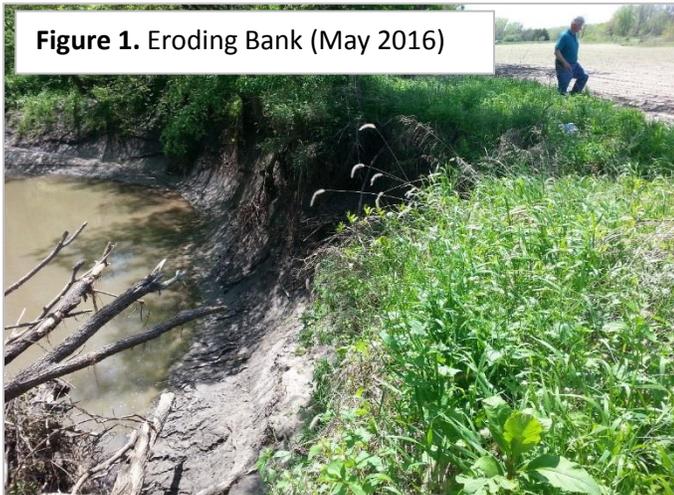
**Figure 1. Eroding Bank (May 2016)**

Don Falk is an Atchison County producer who owns cropland along Little Grasshopper Creek, which is in a WRAPS high priority area for implementation of cropland BMPs in the Delaware River Watershed. Considerable bank erosion was occurring along a sharp bend in the creek adjoining his crop field (Figure 1). In 2016, he contacted the Delaware River WRAPS for possible assistance.

The Delaware River WRAPS partnered with the Kansas Forest Service and forestry faculty at Kansas State University to provide technical assistance for the design and installation of a cedar tree revetment (CTR) with willow plantings and a riparian forest buffer. The Delaware WRAPS provided cost-share funding for the project. Average annual soil loss from bank erosion at the project site from 1991-2016 was estimated at 55 tons per year.

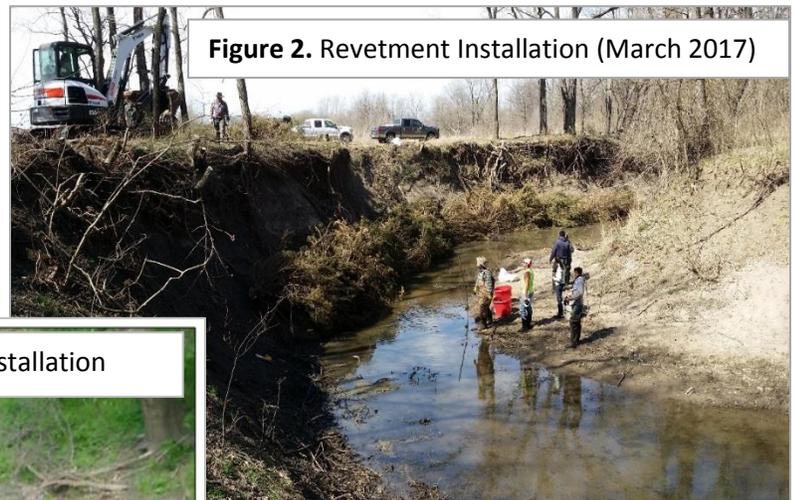
**Figure 2. Revetment Installation (March 2017)**

The revetment and willow plantings were installed in March of 2017, protecting approximately 380 feet of streambank (Figure 2). The riparian buffer, consisting of oak, sycamore and native grasses, was installed a few weeks later covering approximately .33 acres. Vegetation immediately next to the

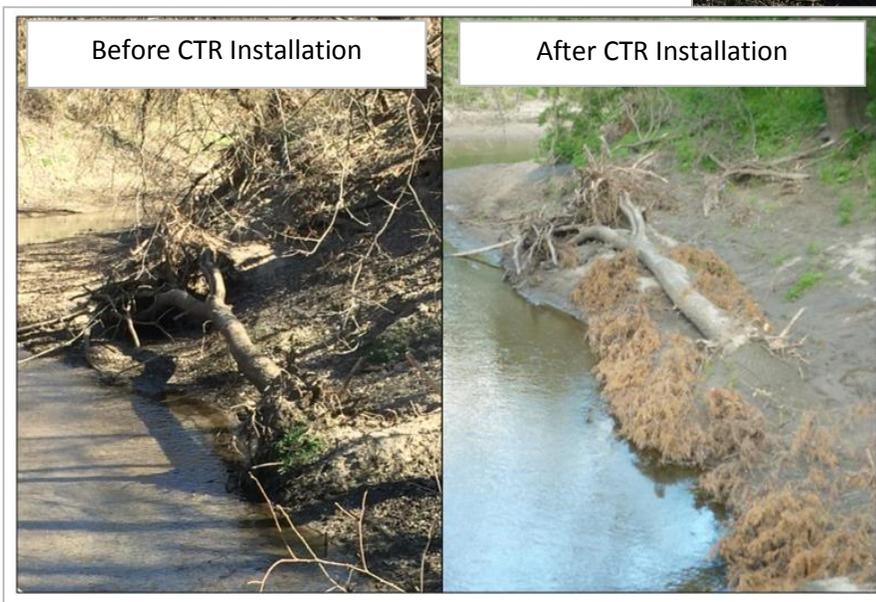
**Figure 3. Sediment Deposition**

cedar tree revetment was also *re*-planted. Normally, *re*-planting means something has gone wrong, but in this case, it means the project is working faster than expected! The cedar tree skeletons caught so much sediment in the first few high flows after installation that the willows were completely silted over (Figure 3). An estimated 158 cubic yards of sediment was trapped from high flows in March & April, with some places having as much as 4 feet of sediment deposited. Willows were replanted, and the new silt bench allowed for planting of additional woody vegetation – i.e. sycamore trees (Figure 4).

**Before CTR Installation**

**After CTR Installation**

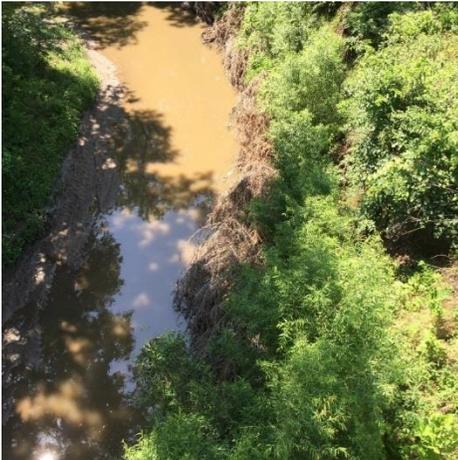
View Looking Upstream

The project is serving as a research site for KSU faculty and students involving periodic measurements to assess project impacts on bank erosion and sediment deposition, including the installation of bank pins at the project site and at a control site near the project. Figure 5 shows recent photos of the project site.

**Figure 5. Project Site - July 2018**
